118th Avenue SE Sidewalk Expansion Critical Areas Report

Prepared for
City of Bellevue

November 2017

Prepared by
Parametrix

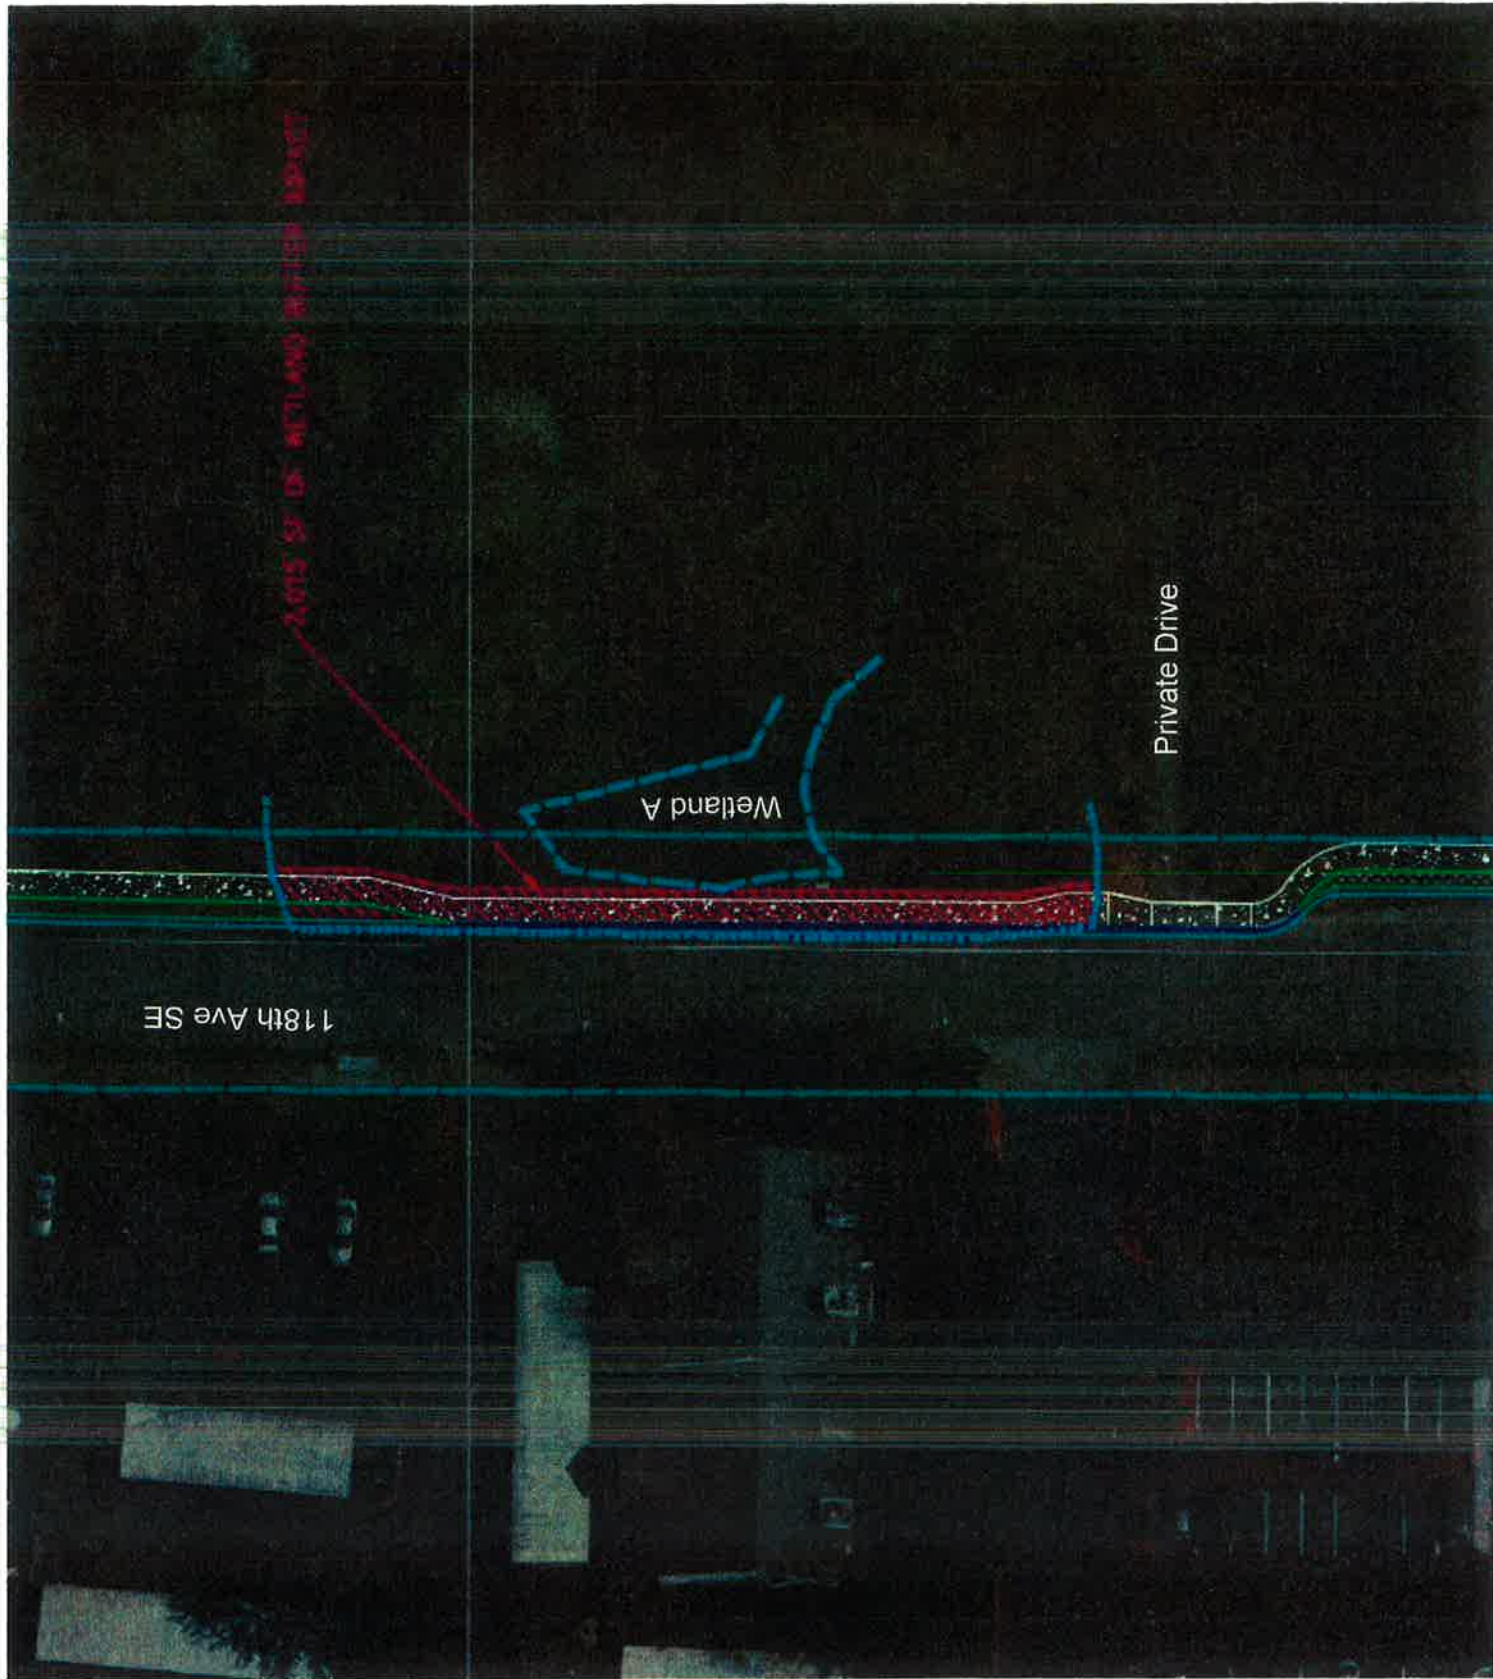
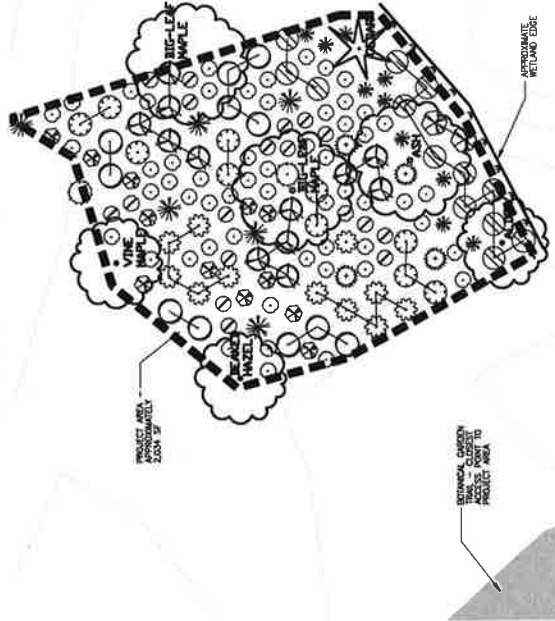
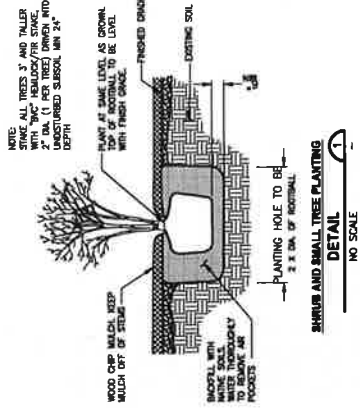
MITIGATION DETAILS		SHT	MP02	OF	X
--------------------	--	-----	------	----	---

Symbol	Cannaceae, Nymphaeaceae	Botanical Name	Maximum Size	Notes
	12	Inside-out Flower	♂ Container	-
	17	Redwood Serril	♂ Container	-
	10	Lady Fern	♂ Container	-
	57	Sword Fern	♂ Container	-
	22	Stake (epoca of 4.5" o.c.)	4" Tall HL	2 to 3 trunks
	22	Western Serviceberry	5 Container/24" HL	-
	22	Pacific Huckleb	4" Tall HL	2 to 3 trunks
	22	Vine Maple	4" Tall HL	-
	12	Indian Plum	6" Container/24" HL	-
		Lusitana Outflow (epoca of 4.5" o.c.)		
	2	Pacific Willow	3" Dia. x 3' long live stakes	-
	13	Red-leaf Dogwood	3" Dia. x 3' long live stakes	-
	8	Trees	4" Tall HL	Not clipped or sheared
	4	Western Red Cedar	4" Tall HL	Not clipped or sheared
	4	Slake Spruce	4" Tall HL	Not clipped or sheared
	2	Western Hemlock	4" Tall HL	Not clipped or sheared
		Approximate location		
		Exiting trees to remove

2. Install a color bag waste to grade as a temporary erosion and sediment control (TSC) measure at bottom of slope to prevent erosion and sediment from running off into the wetland area below. TSC must be installed prior to commencing construction.

11. Meet only much. No 3" layer soil must only remain over the surface of the planting area.
12. Contractor shall remove all live stakes at the end of 1 year.

The proposed sidewalk expansion project will not fill or dredge wetlands or streams. The project will displace 2,015 square feet of existing wetland buffer (see Figure E-1, Appendix E). This buffer is currently highly degraded: vegetation is dominated by invasive and other non-native species; the ground surface contains garbage and other debris that runs off the roadway; and the area is regularly mown and cleared to maintain drainage. Overall, the buffer of Wetland A that will be affected provides minimal habitat functions.

Disturbed critical area buffers require a replacement ratio of one-to-one (LUC 20.25H.105.C.3). To compensate for the 2,015 square feet of unavoidable impacts to the wetland buffer, the City will enhance an equivalent area of buffer in an adjacent wetland located outside of the road right-of-way in Wilburton Hill Park (see Figure 4, Appendix E). The City of Bellevue Parks & Community Services (Parks) staff reviewed possible locations of this restoration work and selected a wetland buffer dominated by an invasive plant (Himalayan blackberry). The remainder of the buffer and the wetland in the vicinity is dominated by native species. As such, this restoration work will both enhance native habitat within the buffer area to be restored, and add resiliency to the remainder of the wetland and buffer by eliminating an isolated invasive species infestation. The work will enhance short- and long-term habitat conditions through promoting native species coverage and supporting the re-establishment of diverse native forested conditions. At a minimum, the proposed buffer mitigation offsets the functions lost as a result of project impacts and likely exceeds them through short- and long-term habitat improvements.

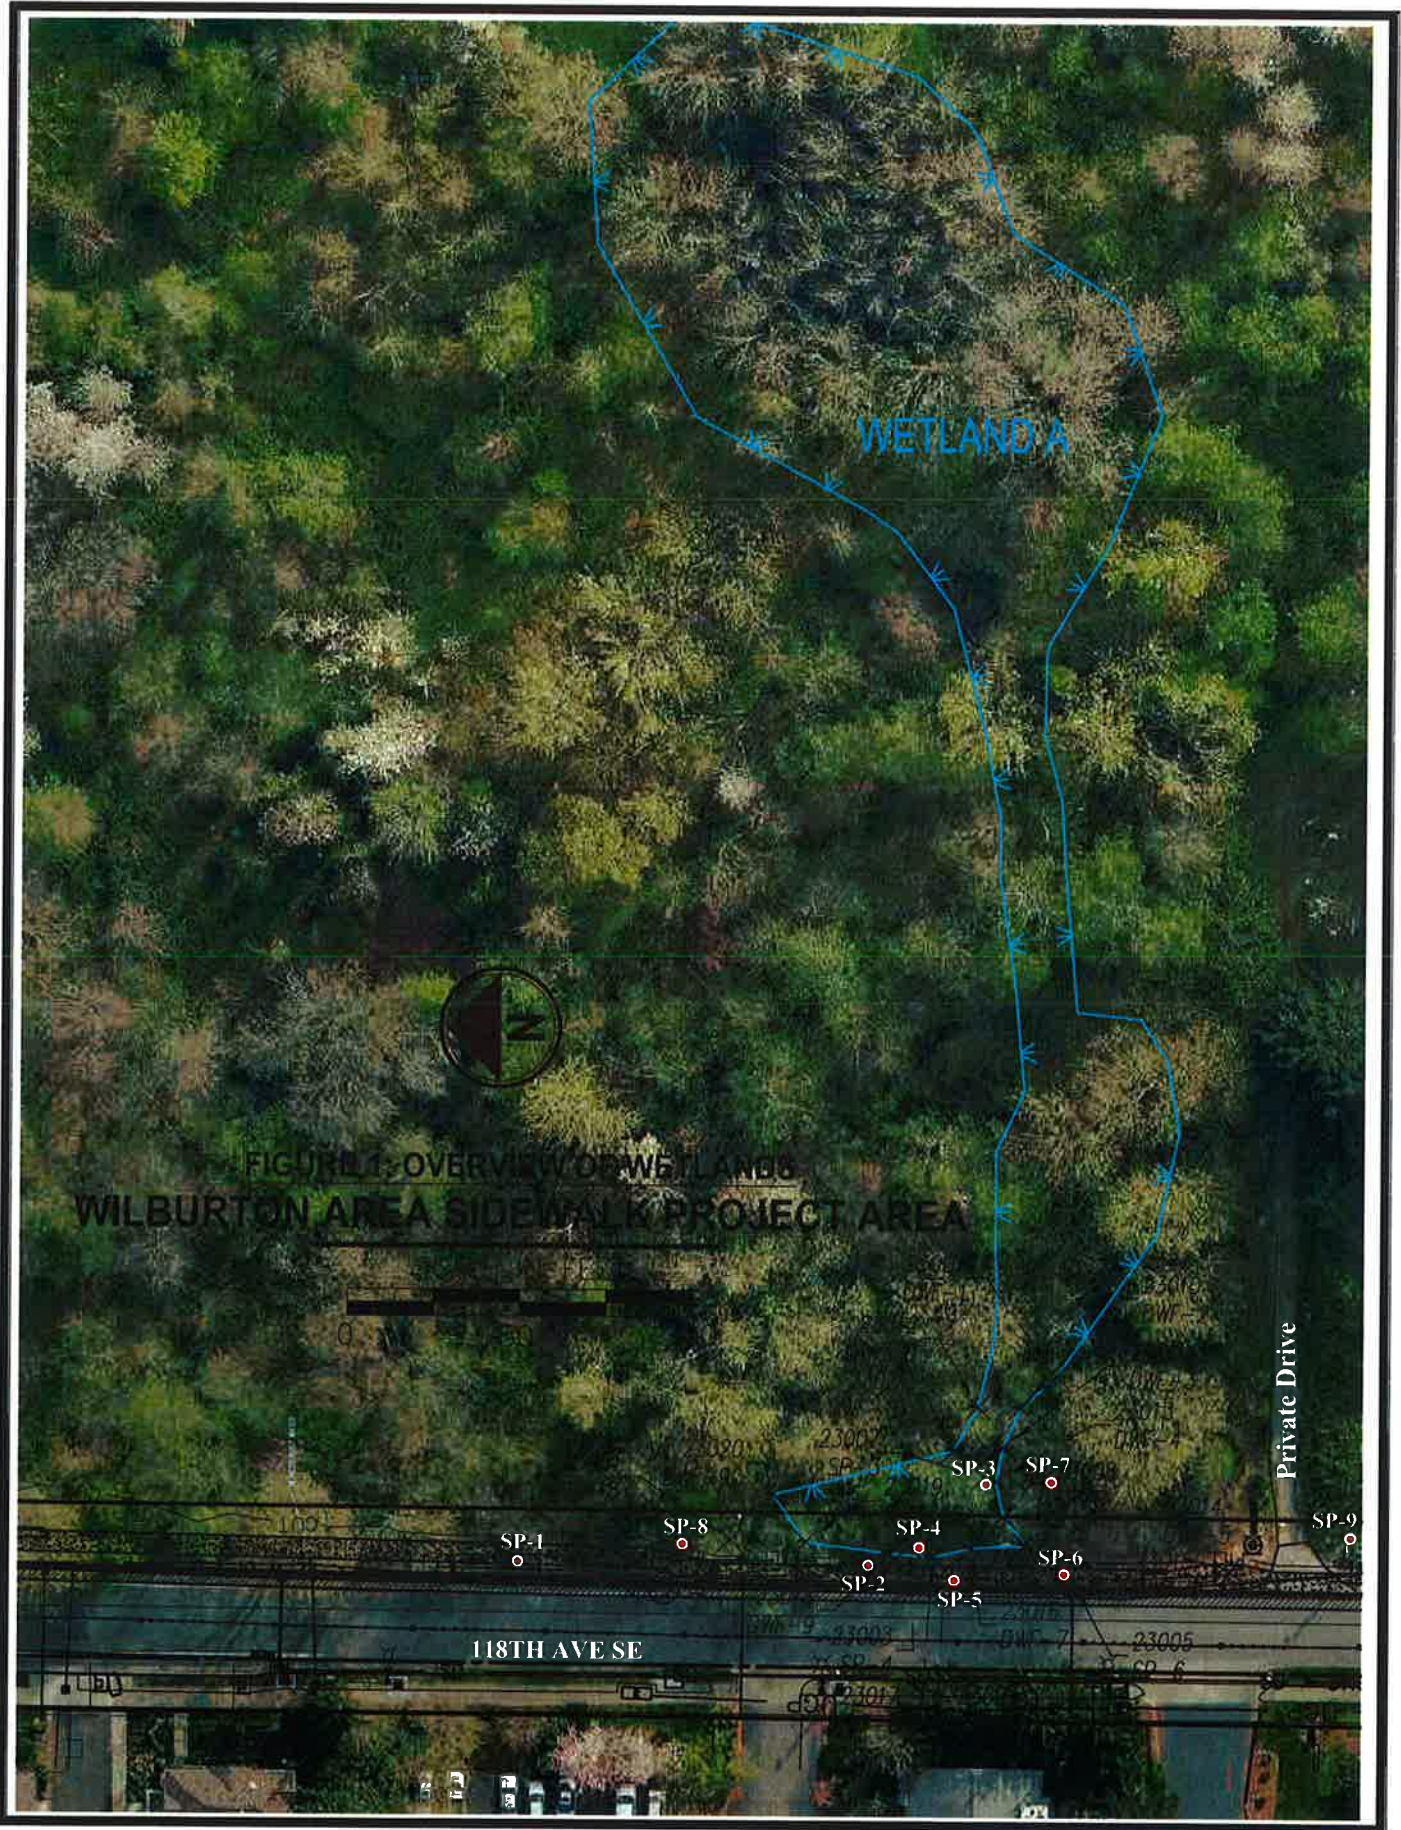
One wetland (Wetland A) was identified in the study area (Figure 3-1). A detailed description of the wetland is presented below. The NRCS (2017b) WETS table indicates drier conditions than normal for the 3 months prior to the field investigations. In addition, the delineation was conducted during the driest period of the year. As such, direct observation of wetland hydrology was not necessarily expected; therefore, the presence of secondary hydrology indicators, as well as hydric soils and hydrophytic vegetation, was used to determine wetland conditions.

Four sample points were collected within the ditch parallel to 118th Avenue SE, which indicated upland conditions in this location (see Figure 3-1 and Appendix B). No streams were identified within the study area.

Wetland A is a forested wetland that extends from the ditch along the east side of 118th Avenue SE several hundred feet into Wilburton Hill Park and is contiguous with the wetland previously mapped in the park (Skillings Connolly Environmental 2007; see description above). A 10-foot-wide wetland swale, dominated by Himalayan blackberry (*Rubus armeniacus*), connects these wetland subunits, which results in one contiguous wetland. Water appears to be impounded within a depression in the westernmost portion of the wetland, which outlets through the wetland swale towards 118th Avenue SE, eventually discharging to the roadside ditch. Groundwater expression further augments hydrology in the lower portion of the wetland, with sloped wetland areas occurring above and north of the swale. During the field investigation, the swale was vegetated with hydrophytic plants and showed no scour, bed, or banks indicative of a stream. Hydric soils were contiguous throughout the wetland.

Soils sampled within Wetland A meet the indicators for Depleted Matrix (F3) and Redox Dark Surface (F6) (see data forms SP-3 and SP-4, Appendix B).
